# TOWN OF PALM BEACH

## SHORE PROTECTION BOARD MEETING

### AGENDA

**TUESDAY, JANUARY 23, 2018**

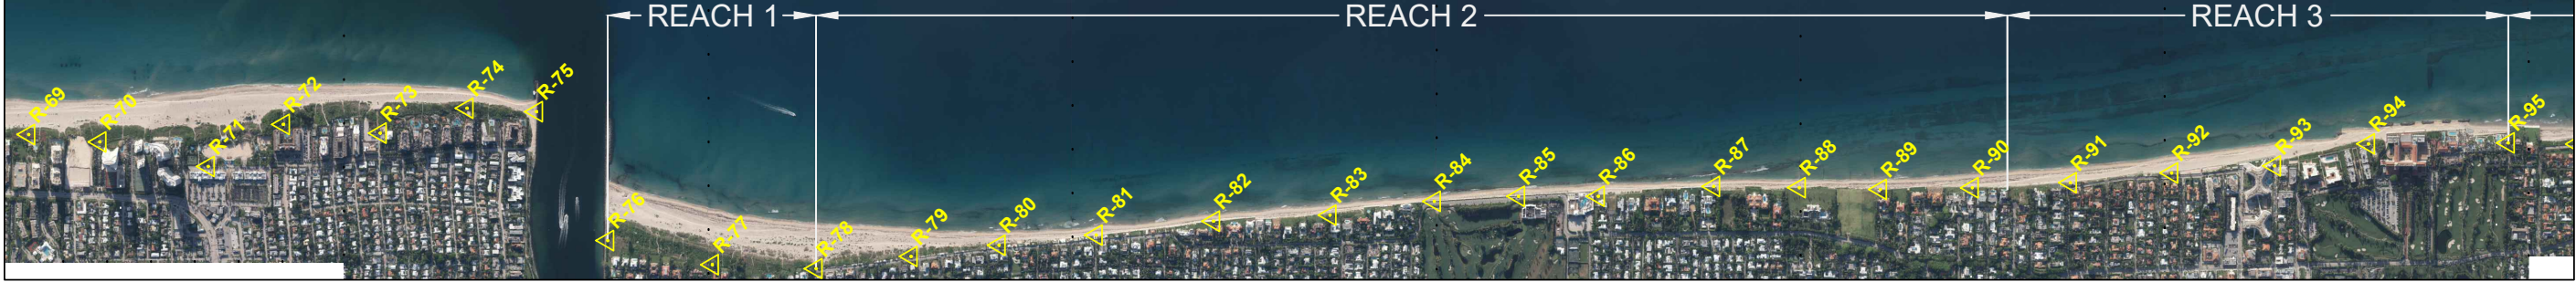
Figure 1a  
Shoreline Changes

This segment comprises both north and south segments of the Mid-Town Beach Renourishment project. Over this monitoring period, the reach exhibited a net shoreline recession of 9.4 feet. Recession was most significant within the central portion of the area from R-97 to R-101. A maximum recession of 43.3 feet occurred at R-97. A portion of the recession observed is attributable to anticipated adjustment of the constructed beach profile from the 2015 Mid-Town nourishment project. The observed magnitude, however, is significantly greater than anticipated project-related cross-shore adjustment.

This segment exhibited a net volumetric loss of 115,740 cy. A prominent area of volumetric loss occurred between R-94 and R-101, within the area approximately from Royal Palm Way to El Brillo Way. In total, the volumetric loss in this area was on the order of 144,907 cy. Small gains were observed in the northern portion of the Mid-Town shoreline segment.

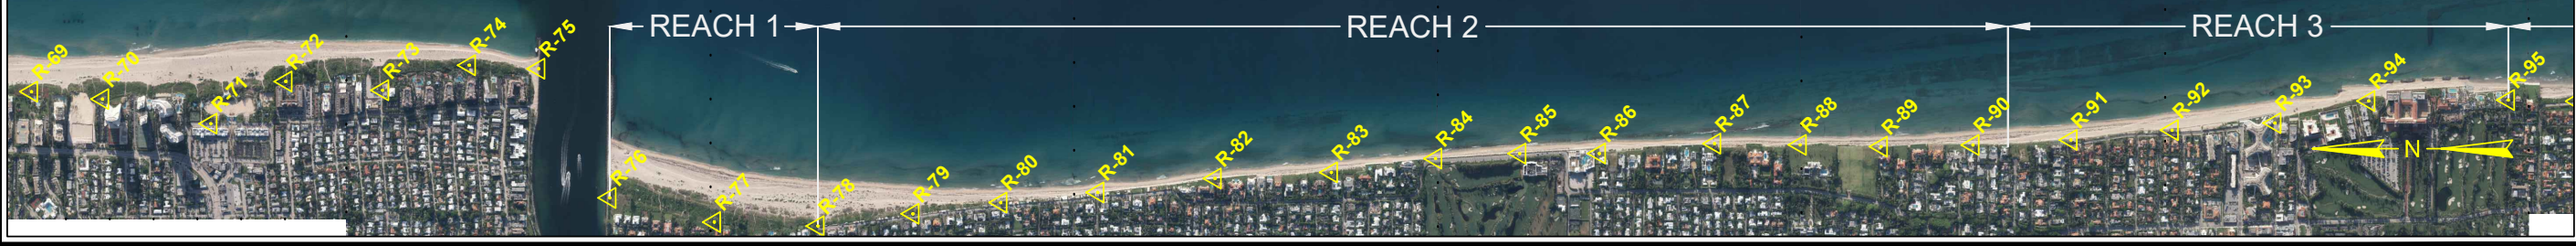
Figure 2a  
Sep. 2016 - Aug. 2017 Volume Changes

SEP. 2016 - AUG. 2017 VOLUME CHANGES ABOVE -26.2' NAVD  
(CY PER LINEAL FEET)

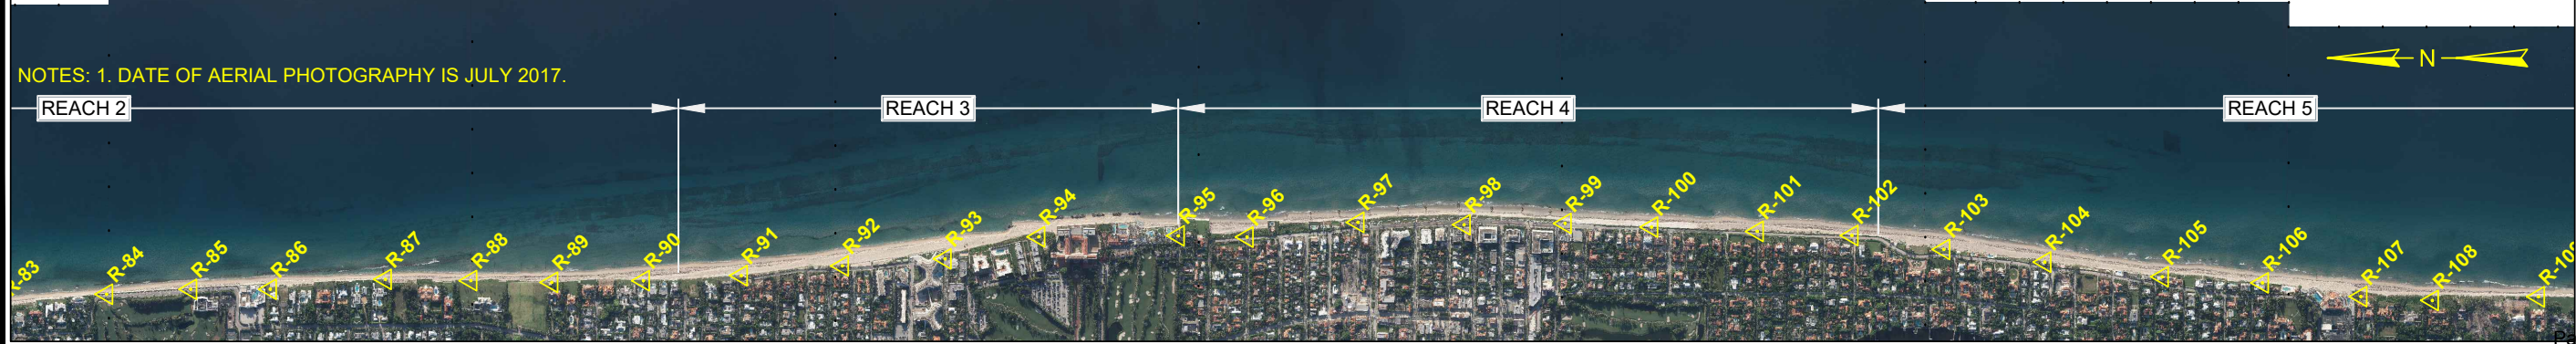
Figure 2b  
Sep. 2016 - Aug. 2017 Volume Changes

SEP. 2016 - AUG. 2017 VOLUME CHANGES ABOVE -26.2' NAVD  
(CY PER LINEAL FEET)

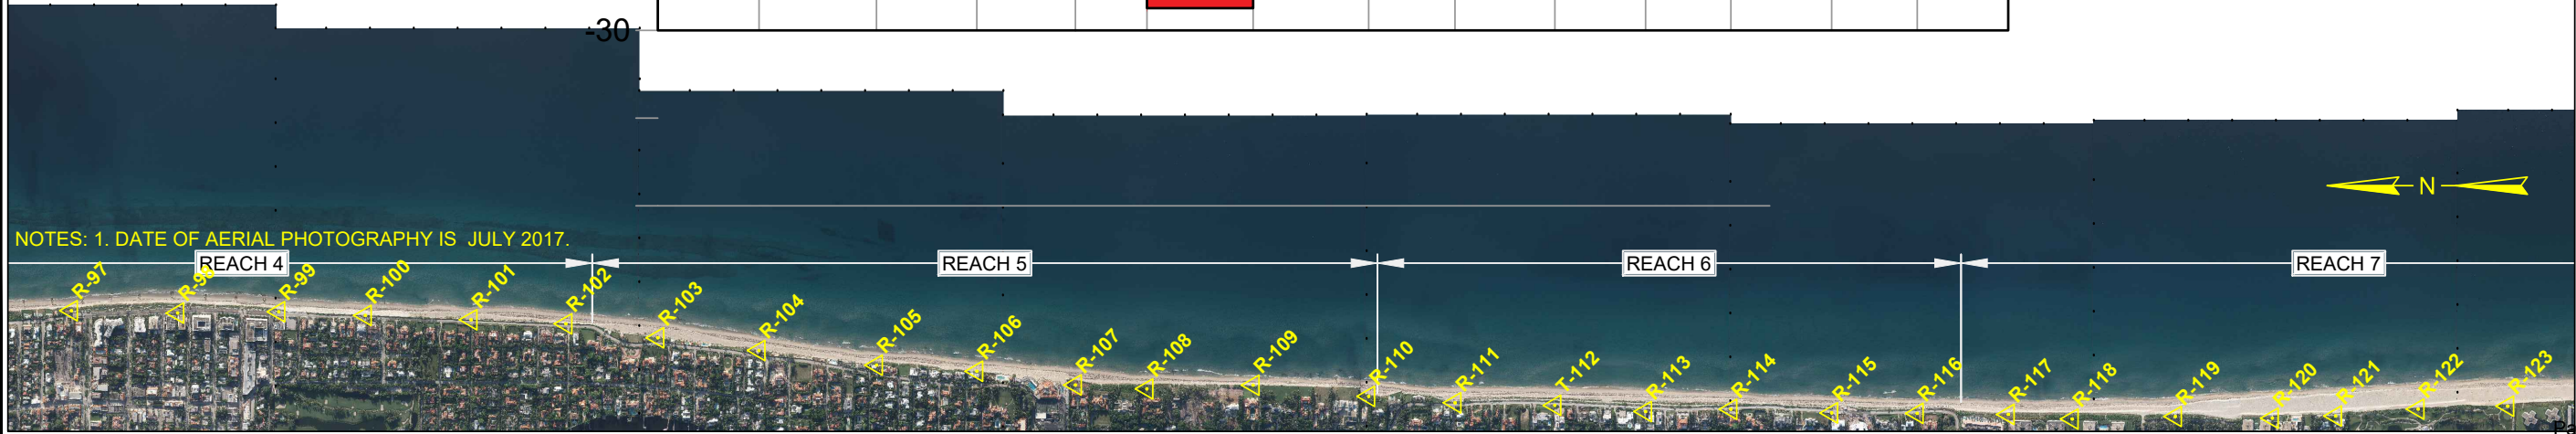
Figure 2c  
Sep. 2016 - Aug. 2017 Volume Changes

SEP. 2016 - AUG. 2017 VOLUME CHANGES ABOVE -26.2' NAVD  
(CY PER LINEAL FEET)
