RE: GAS SERVICE LINE HIT NEAR 232 ANGLER

The following report recaps the events that took place on May 3, 2019 when the gas service line was hit near 232 Angler Ave.

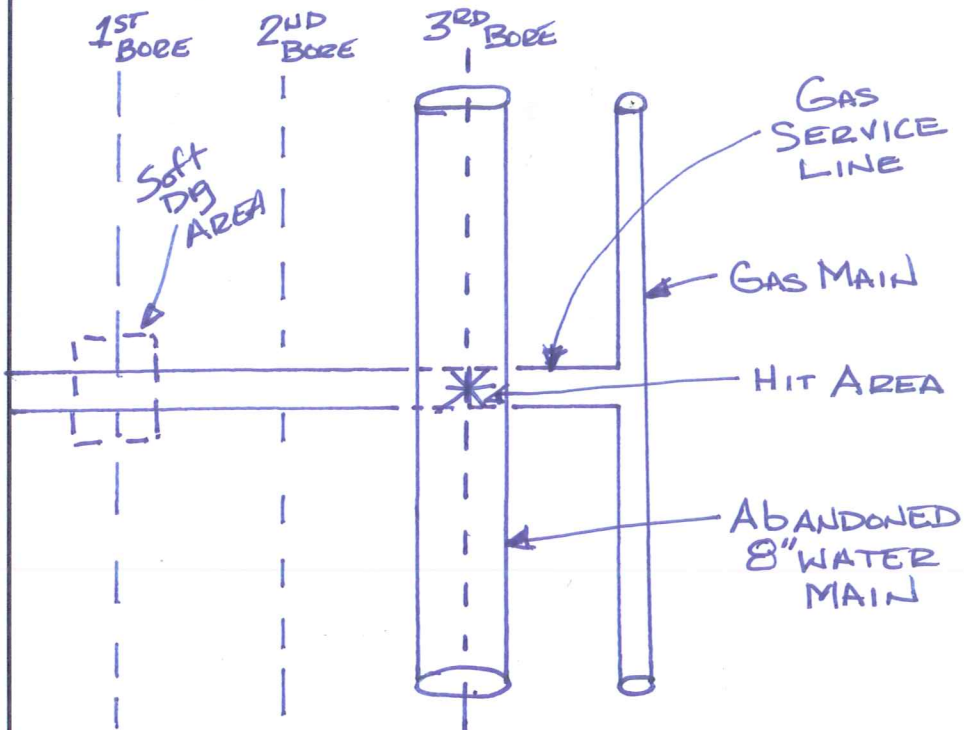
TOP VIEW

The drilling crew had sucessfully made 2 previous drills under this gas service on Thursday and Friday morning. This was the third bore that was made and the reason that the line got hit is because it dropped in elevation to go under an abandoned water main. Bore #1 consisted of 1Ea. 5" AT&T Pipe. Bore #2 consisted of 1 Ea. 5" AT&T, 1 Ea. 2" AT&T, 1 Ea. 1" AT&T, 1 Ea. 3" COMCAST, and 1 Ea. 1" COMCAST pipe. Bore #3 consisted of 5 Ea. 2" FPL pipe.

EXCESS FLOW VALVE

GAS SERVICE  
LINE

ABANDONED WATER MAIN

DRILLING ROD

GAS SERVICE LINE

SOFT DIG AREA

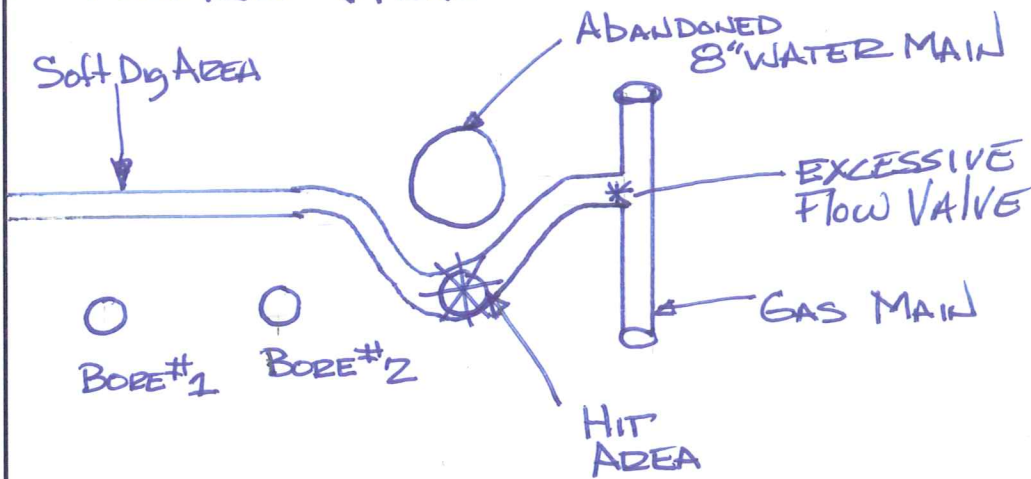
PROFILE VIEW

SOFT DIG AREA

GAS SERVICE LINE

WATER MAIN
